CHAPTER 4

BUILDINGS FROM VOLUME BLOCKS

4.2 Analysis of damage to buildings made of volumetric blocks caused by off-design impacts

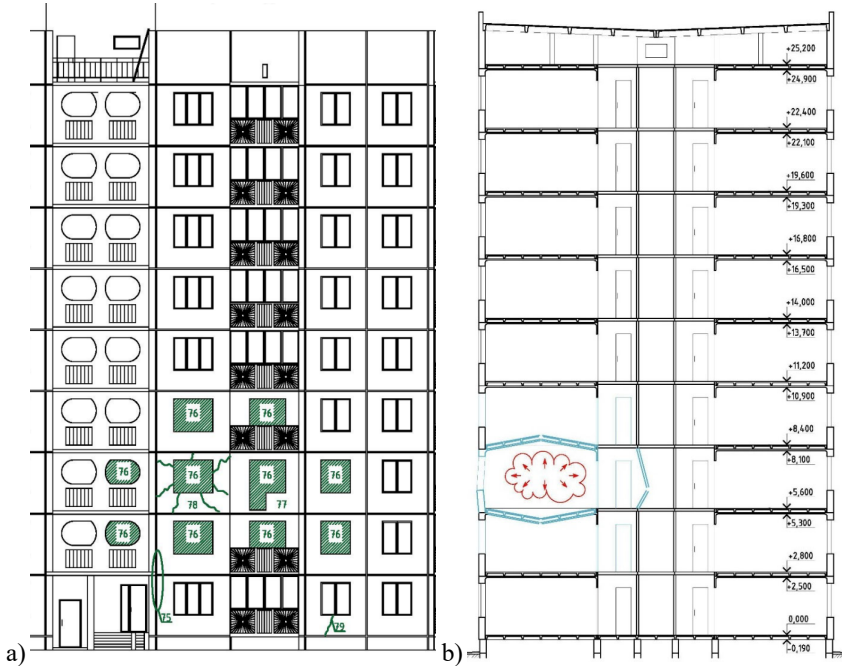
Figure 4.5 – Location of damage to reinforced concrete structures:
a) fragment of the facade; b) cross-section of the building

of building structures and objects” of DSTU 9273:2024 “Guidelines for the inspection of buildings and structures to determine and assess their technical condition” [24]. The identified defects and damages are presented in the damage location diagram (see Figure 4.5) and damage photographs (see Figure 4.6 – 4.13). The identified damages to building structures occurred both during the gas explosion (in the vast majority) and accumulated during the operation of the building.

Technical condition of load-bearing reinforced concrete structures of apartments No. 84, 92, 100, located in the area of the explosion, according to the characteristic full-scale classification features of the technical condition of reinforced concrete structures (Table B.2.1 DSTU 9273:2024 [24]) is assessed as emergency (technical condition category 4) and requires urgent reinforcement of vertical load-bearing reinforced concrete elements and restoration of two interfloor ceilings under and above the apartment in which the explosion occurred (between the 2nd and 3rd floors and the 3rd and 4th floors) (see Figure 4.5).

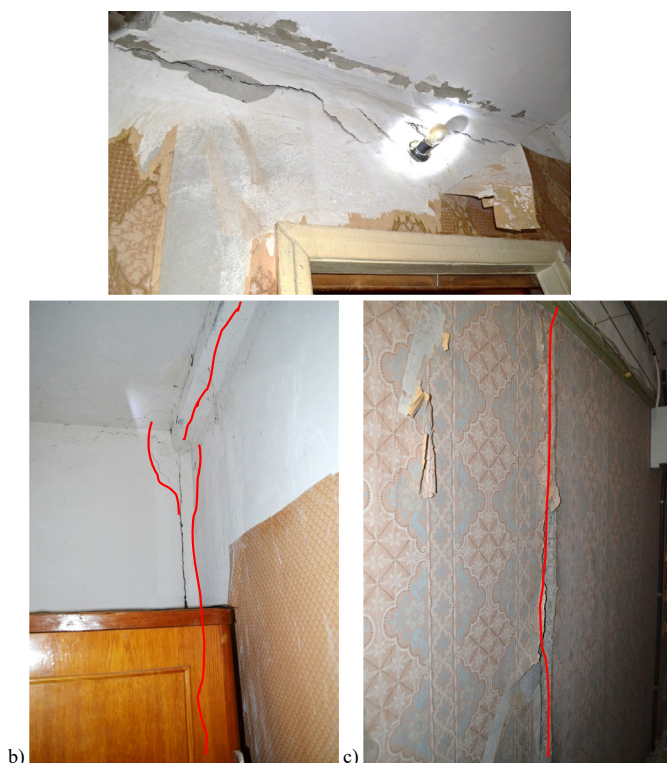
Figure 4.6 (a-c) – Formation of through and surface cracks, fragmentation, peeling of reinforced concrete structures and destruction of the filling of the joints between them within the 1st and 5th floors in the rooms above and below the apartment in which the explosion occurred

- formation of through and surface cracks, fragmentation, peeling of reinforced concrete structures and destruction of the filling of the joints between them within the 1st and 5th floors in the rooms above and below the apartment in which the explosion occurred (see Figure 4.6);

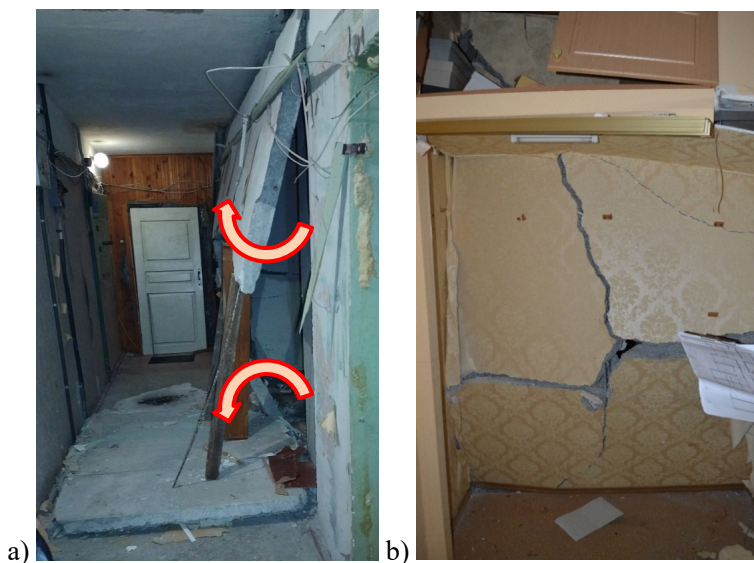
- destruction of 100 mm thick reinforced concrete partitions between apartments on the 3rd floor around the apartment where the explosion occurred (see Figure 4.7);

Figure 4.7 (a-b) – Destruction of 100 mm thick reinforced concrete partitions between apartments on the 3rd floor around the apartment where the explosion occurred

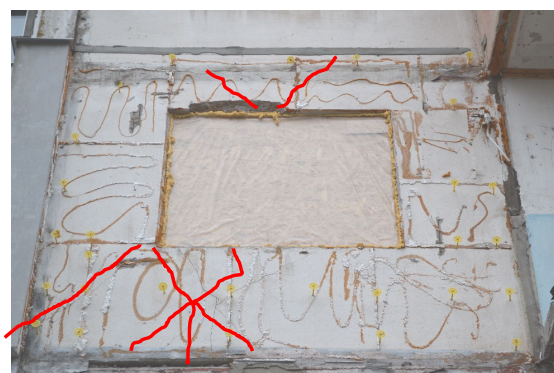
- cracks in the body of the 320 mm thick reinforced concrete exterior wall panels on the 3rd floor around the apartment where the explosion occurred (see Figure 4.8);

Figure 4.8 – Cracks in the body of the 320 mm thick reinforced concrete exterior wall panels on the 3rd floor around the apartment where the explosion occurred

3.4 Damaged corridor panels should be reinforced after installing steel posts at the welding points of the panels (especially on the 3rd floor).

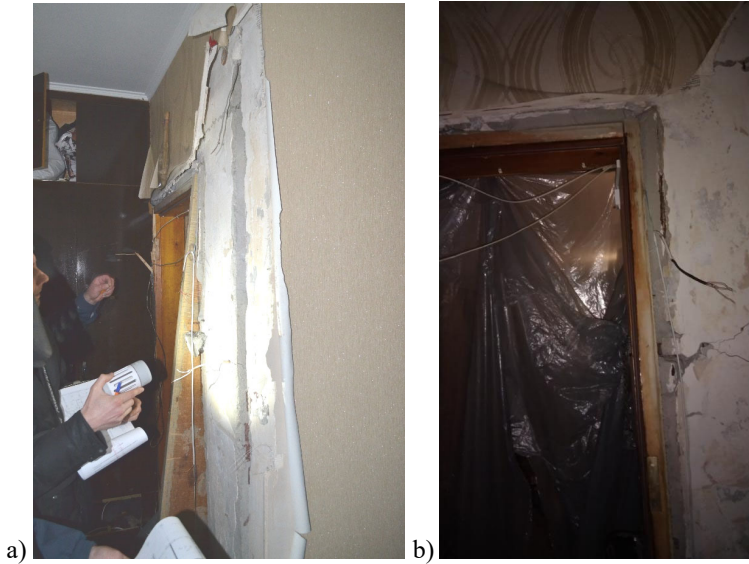
- deformation, departure from the design position of the reinforced concrete block of the doorway of the apartments, which opens onto the landing of the apartment in which the explosion occurred (see Figure 4.9);

Figure 4.9 (a, b) – Deformation, departure from the design position of the reinforced concrete block of the doorway of the apartments, which overlook the staircase of the apartment in which the explosion occurred

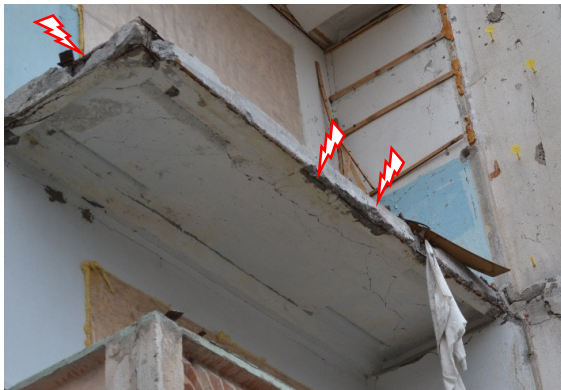
- cracking and excessive deflection of the balcony slab of the apartment on the 3rd floor where the explosion occurred (see Figure 4.10);
- complete destruction of inter-storey reinforced concrete slabs of floors under and above the apartment in which the explosion occurred (between the 2nd and 3rd and 3rd and 4th floors) with exposure, bulging, displacement, loss of adhesion to concrete, reaching the yield point and rupture of reinforcing bars (see Figure 4.11);

Figure 4.10 – Cracking and excessive deflection of the balcony slab of the apartment on the 3rd floor, where the explosion occurred

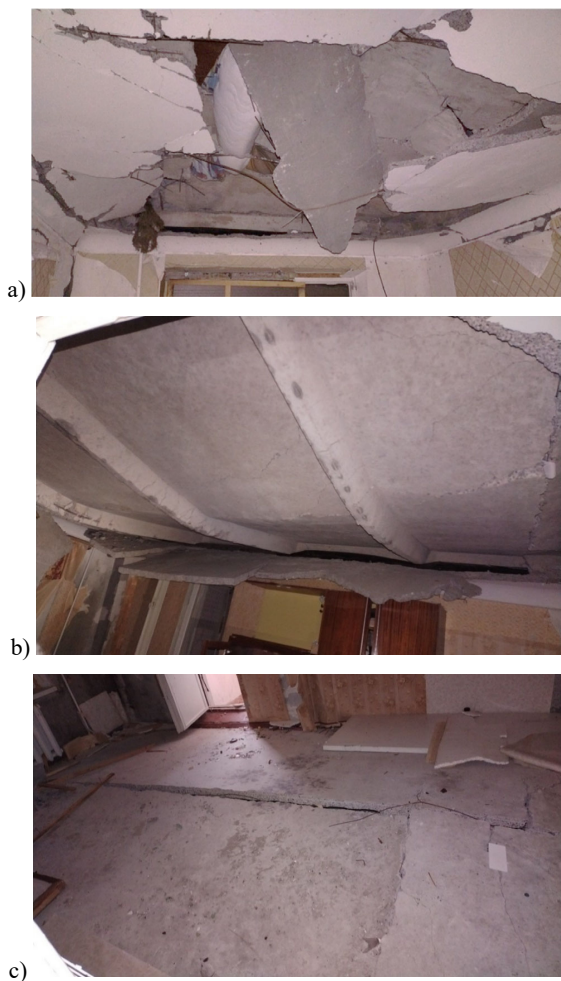
Figure 4.11 – Complete destruction of interfloor ceilings below and above the apartment in which the explosion occurred (between the 2nd and 3rd and 3rd and 4th floors) with exposure, bulging, displacement, loss of adhesion to concrete, reaching the yield point and rupture of reinforcing bars

1.3 Dismantle fragments of destroyed reinforced concrete floor slabs. Dismantle from top to bottom using a diamond cutting tool to minimize impact (dynamic) loads. Dismantle destroyed reinforced concrete fragments, at the choice of the contractor, may be carried out through windows by hanging (slinging) the dismantled fragments to a suspension system or along the existing stairs of the building, cutting the destroyed reinforced concrete slab into hand-weight fragments. Cutting of destroyed floor fragments should be performed along the letter axes (across the cracks) to prevent uncontrolled instantaneous (catastrophic) collapse of large fragments of floor slabs.

1.4 To install steel elements to reinforce wall structures and restore interfloor ceiling structures made of prefabricated steel structures and monolithic reinforced concrete floor slabs.

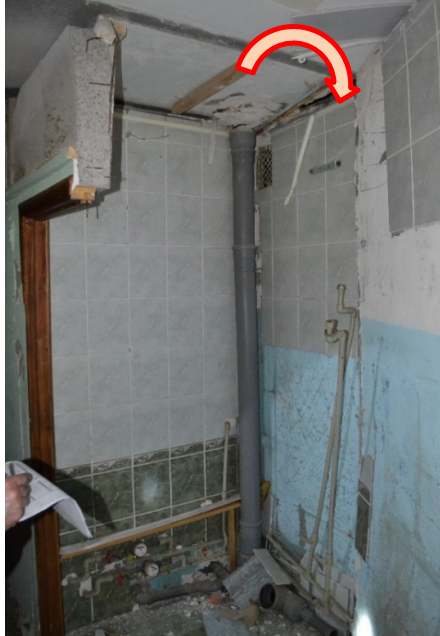
- departure from the design position of the internal partition of the bathroom of the apartment on the 3rd floor, where the explosion occurred (see Figure 4.12);

Figure 4.12 – Exit from the design position of the internal partition of the bathroom of the apartment on the 3rd floor, where the explosion occurred

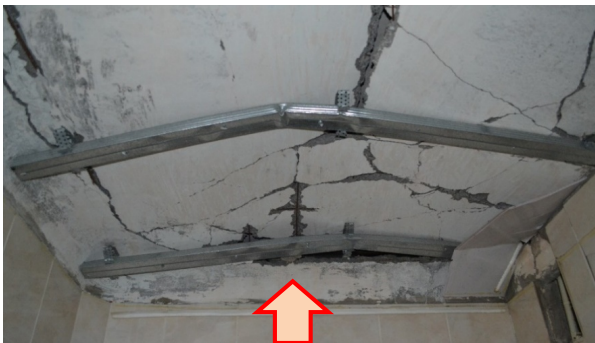
- destruction of the bathroom floor slab above the apartment in which the explosion occurred (see Figure 4.13).

Figure 4.13 – Destruction of the bathroom floor slab above the apartment where the explosion occurred
