CHAPTER 5

ANTENNA COMMUNICATION STRUCTURES

5.1 General information about the operation of communication antenna structures under martial law

5.3 Analysis of damage to supporting structures of communication antenna structures caused by military operations

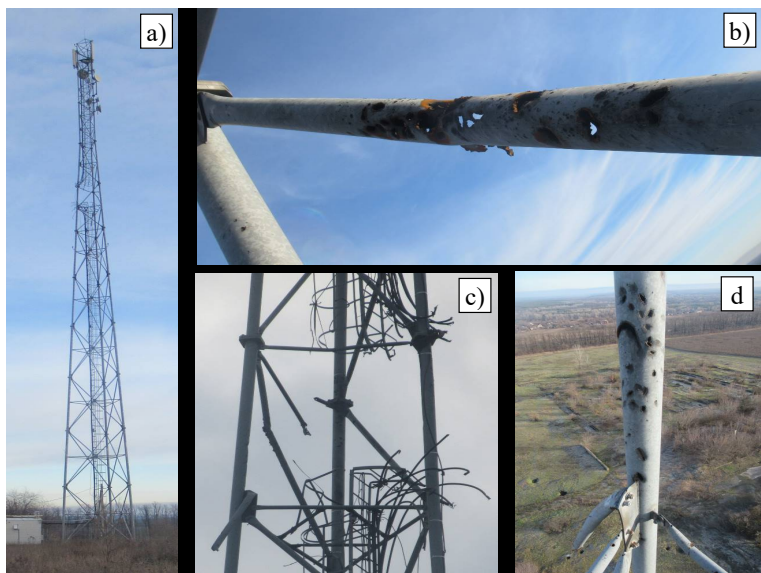
Figure 5.3 shows the damage to the tower with a height of $H = 60$ m. The tower is a spatial lattice structure in the form of a truncated pyramid with a triangular cross-section. The faces of the tower are flat trusses with

Figure 5.3 – Damage to the tower with a height of $H = 60$ m:
a) general view of the tower; c) view of damage to sections C7-C8;
b, d) through holes in the tower elements

Damage to the belts and destruction of the lattice elements of the tower sections C7-C8 at an altitude of +36,000...+48,000 m due to a hit by an FPV drone. There are numerous through holes ($\varnothing 20$ -50 mm) in the belts, struts and braces of the tower, destruction (rupture of pipes $\varnothing 89 \times 4$ mm and $\varnothing 76 \times 4$ mm) of struts and braces. General deformations of the tower shaft and abnormal deviations of the shaft axis from the vertical were detected. Figure 5.4 shows a combined support $H = 42$ m. In the lower part, a conical reinforced concrete column SK26.2-1.1 with a height of 26 m is used, which is buried in the ground by 6 m. At a height of 20 m from the ground surface, a spatial lattice quadrangular prism with 4 sections with a total height of 22 m is installed on it, the elements of which are made of

| № | Architectural and structural solution of a communication antenna structure | Damage characteristics: | | | Technical condition category [24] | Recovery recommendations |
|---|---|---|---|--|---|--|
| 1 | The 60 m high tower is a spatial lattice structure of 11 sections in the form of a truncated pyramid with a triangular cross-section. The faces of the tower are flat trusses with a rhombic and triangular lattice with struts made of steel pipes of different diameters. | hitting an FPV drone | elevation +36,00...+48,00 m (sections C7-C8) | through holes (Ø20-50 mm), rupture of tubes of belts, struts and tower braces | Most defects and damage resulting from military operations present an immediate risk of destruction to communication antenna structures, even when the calculated wind load threshold is not reached. Such conditions result in an emergency status for the structures, classified as technical condition category 4 (emergency). | Structural elements exhibiting these defects and damage necessitate complete replacement or restoration of affected sections, ensuring spatial geometry is maintained and partial dismantling of upper sections is performed. Strengthening individual nodes and elements is considered inefficient and temporary, as it does not address the overall reliability and durability of the communication antenna structure. |

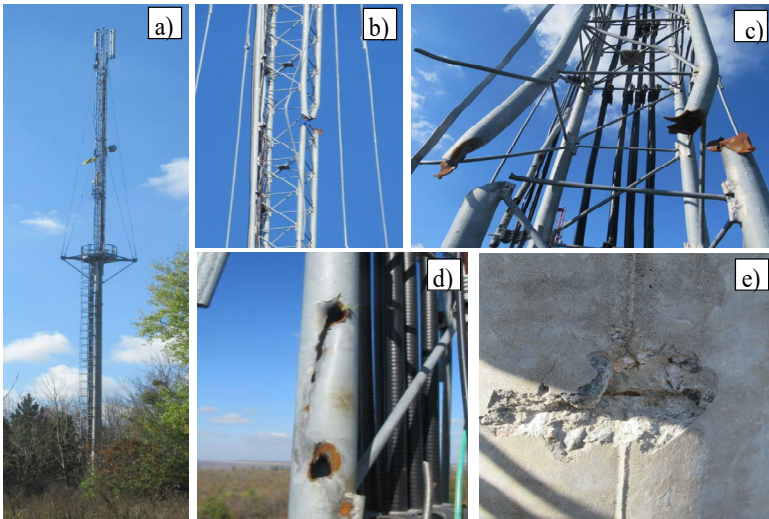
pipes and round steel. The impact of the projectile fragments resulted in the severing of two out of four belts of the steel extension. Deformation of the lattice elements, multiple through holes in the tubular belts of the steel extension, and damage to the concrete protective layer exposing the reinforcement of the reinforced concrete column were also observed.

Figure 5.4 – Damage to the combined support $H = 42$ m:

a) general view of the support; b, c) two of the 4 belts are broken; d) holes in the elements; e) damage to the reinforced concrete column

| № | Architectural and structural solution of a communication antenna structure | Damage characteristics: | | | Technical condition category [24] | Recovery recommendations |
|---|---|---|---|--|---|--|
| 2 | Combined support H = 42 m. In the lower part, a conical reinforced concrete column SK26.2-1.1 with a height of 26 m is used. At a height of 20 m from the ground surface, a spatial lattice quadrangular prism with a height of 22 m is installed on it, made of pipes and round steel. | hit by mortar shell fragments | elevation +35,000 m (section C3 of the extension) | two of the 4 belts are cut, numerous through holes in the tubular belts of the steel extension | | |

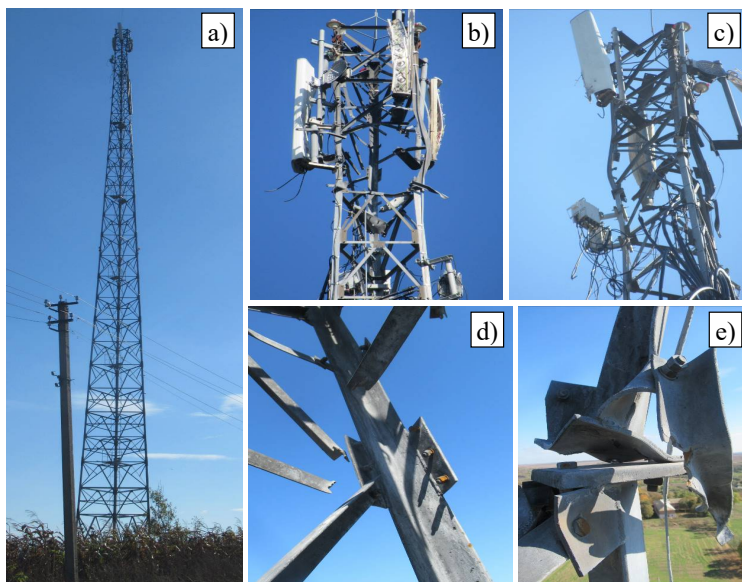
Figure 5.5 shows the damage to a tower with a height of $H = 60$ m. The tower is a spatial lattice structure in the form of a truncated pyramid with a triangular cross-section. The faces of the tower are flat trusses with a semi-oblique lattice, the elements of which are made of steel angles.

The shell hit led to the destruction of the antenna-feeder equipment located in the upper part of the tower. Deformation of the upper section belts due to the action of the shock wave, destruction (rupture) of the lattice elements was noted. Destruction of the flange connections of the tower upper sections due to the impact of the shock-explosive load.

Figure 5.5 – Damage to a tower with a height of $H = 60$ m:
a) general view of the tower; b, c) view of damage to the antenna-
feeder equipment, deformation of the upper section belts;
d) destruction (rupture) of the lattice elements made of angle steel;
e) destruction of flange joints due to shock-explosive loading

| № | Architectural and structural solution of a communication antenna structure | Damage characteristics: | | | Technical condition category [24] | Recovery recommendations |
|---|---|---|---|--|---|--|
| 3 | Tower H = 60 m in the form of a truncated pyramid with a triangular cross-section. The faces of the tower are flat trusses with a semi-oblique lattice, the elements of which are made of steel angles. | projectile impact | note +50,000...+60,000 m | belt deformations, destruction of flanges, gratings | | |

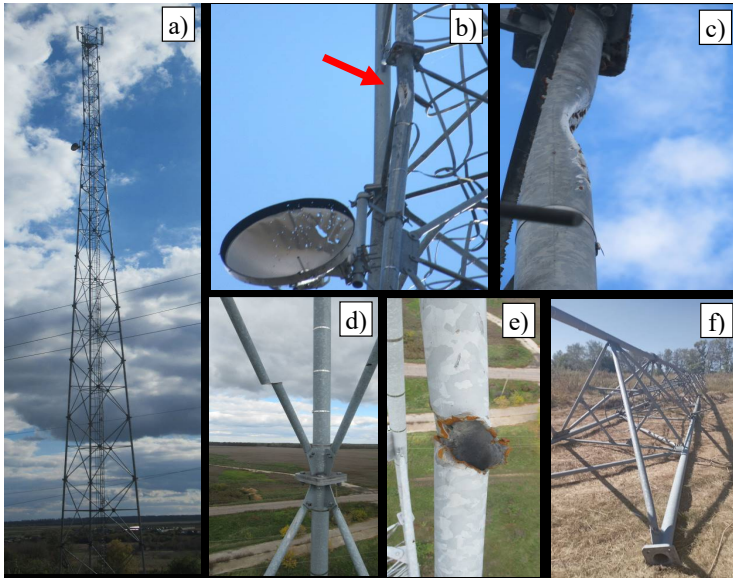
Figure 5.6 shows the damage to the tower with a height of $H = 70$ m. The tower is a spatial lattice structure in the form of a truncated pyramid with a triangular cross-section. The faces of the tower are flat trusses with a rhombic and triangular lattice with struts, the elements of which are made of different diameters of steel pipes. The tower consists of 12 sections; the sections are connected by flanges.

As a result of the shell fragments hitting the belt, deformations and dents occurred, as well as destruction and rupture of the struts of the tower sections.

Figure 5.6 – Damage to a tower with a height of $H = 70$ m:
a) general view of the tower; b, c) formation of deformations
and dents in the belt; d, e) destruction (rupture) of lattice elements;
e) process of dismantling part of the damaged sections
for their restoration

| 1 | 2 | 3 | 4 | 5 | 6 | 7 |
|---|--|---|---|---|---|--|
| 4 | Tower H = 70 m in the form of a truncated pyramid of triangular cross-section. The faces of the tower are flat trusses with a rhombic and triangular lattice with struts, made of steel pipes of different diameters. The tower consists of 12 sections; the connections of the sections are flanged. | hit by mortar shell fragments | elevation +60,000...+70,000 m | deformations and dents in the belt, destruction and rupture of the braces of the tower sections | Most defects and damage resulting from military operations present an immediate risk of destroying communication antenna structures, even when the calculated wind load threshold is not reached. Such conditions result in an emergency status for the structures, classified as technical condition category 4 (emergency). | Structural elements exhibiting these defects and damage necessitate complete replacement or restoration of affected sections, ensuring spatial geometry is maintained and partial dismantling of upper sections is performed. Strengthening individual nodes and elements is considered inefficient and temporary, as it does not address the overall reliability and durability of the communication antenna structure. |

To restore the elements, part of the tower sections were dismantled, followed by the replacement of damaged elements and the installation of the tower in the design position.

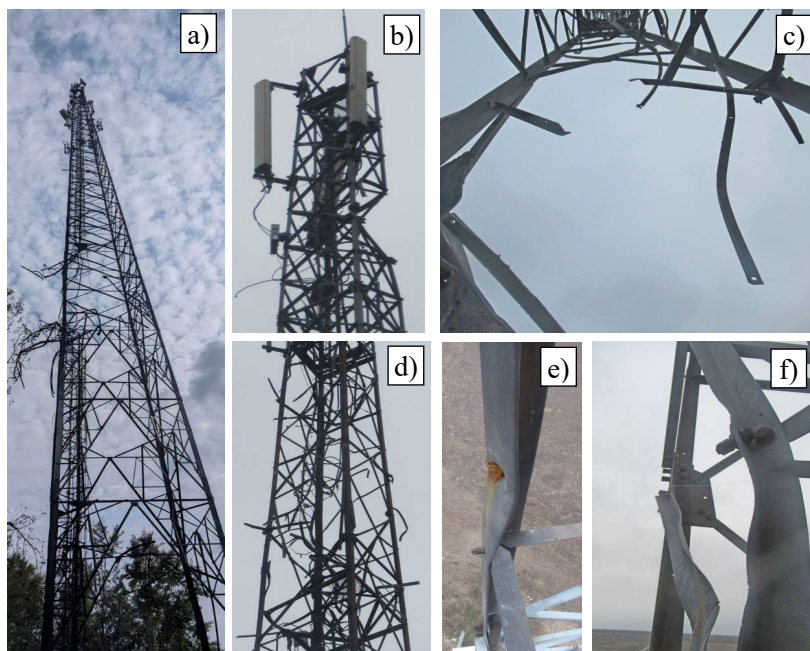
Figure 5.7 shows the damage to the tower with a height of $H = 60$ m. The tower is a spatial lattice structure of a quadrangular cross-section with a rhombic lattice with additional truss elements up to the mark +20,000, with a rhombic lattice from the mark +20,000 to the mark +48,000, a cross lattice from the mark. 48,000 m, the elements of which are made of steel angles. The tower consists of 11 sections, which are bolted together through belt plates.

Through-going destruction of almost all elements of the tower sections' lattice C8-C11 was noted. Deformation (bending) of the belt of the C7 section and the formation of a dent in the belt. The presence of through-going holes in the elements of the lattice of the tower, destruction and rupture of the braces of the elements as a result of being hit by a kamikaze attack drone.

**Figure 5.7 – Damage to the tower with a height of $H = 60$ m:
 a) general view of the tower; b) damage to the tower belt;
 c, d, e) through-the-wall destruction of almost all elements
 of the tower lattice of sections C8-C11; e) deformation
 and dents of the section C7**

| 1 | 2 | 3 | 4 | 5 | 6 | 7 |
|---|--|---|---|---|---|--|
| 5 | Tower H = 60 m in the form of a truncated pyramid of a quadrangular cross-section with a rhombic lattice with splines up to the mark +20,000, with a rhombic lattice from the mark +20,000 to the mark +48,000, a cross lattice from the mark 48,000, made of steel angles. The tower consists of 11 sections, the sections are bolted together. | Hitting 2 Shahed kamikaze drones | elevation +25,000...+70,000 m | through-the-wall failure of the C8-C11 lattice of the tower sections. Bending of the C7 section belt and dent formation | | |

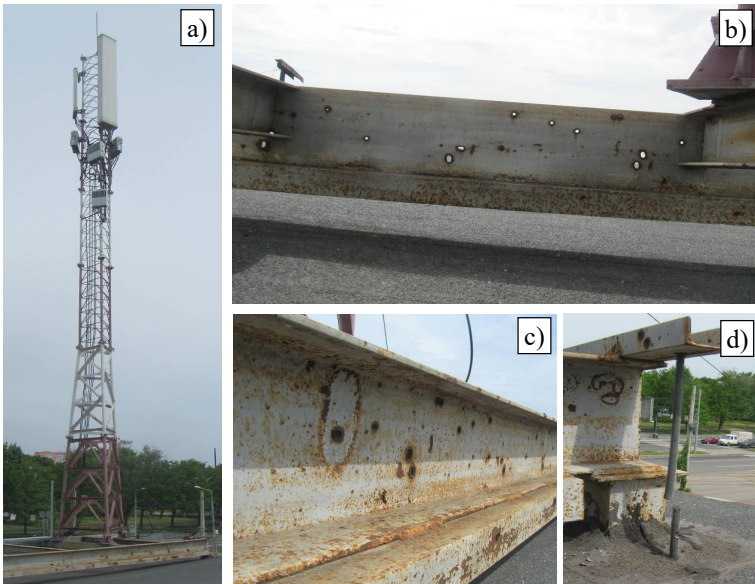
Figure 5.8 shows the damage to a tower with a height of $H = 12$ m on the roof of a one-story administrative building. The tower is a spatial lattice structure of triangular cross-section with a semi-oblique and oblique lattice, the elements of which are made of steel pipes (belts) and angles (lattice elements). The tower consists of 6 sections, the sections are connected by flanges. The tower rests on a supporting frame of channels, fixed to the coating with the help of traverses and M20 studs.

Weakening of the beam cross-section walls with numerous through holes ($d = 10 \dots 30$ mm), rupture of the support frame stud from damage by

shrapnel fragments of the support frame attachment to the building's load-bearing structures were detected.

Figure 5.8 – Damage to a tower with a height of $H = 12$ m on the roof of a one-story administrative building:
a) general view of the tower and the supporting frame;
b, c) weakening of the walls cross-section of the channel beams with numerous through holes ($d = 10...30$ mm) from damage by shrapnel fragments;
d) rupture of the supporting frame stud in the attachment to the building's load-bearing structures

| 1 | 2 | 3 | 4 | 5 | 6 | 7 |
|---|--|---|---|---|---|--|
| 6 | Tower H = 12 m, installed on the roof of the building, triangular cross-section with a semi-oblique and oblique lattice, the elements of which are made of pipes and angles. The tower consists of 6 sections, the connections of the sections are flanged. The tower rests on a supporting frame made of channels. | shrapnel injuries | elevation +0.000...+3.000 m | weakening of beams with through holes (d=10-30 mm), breakage of the support frame stud | | |

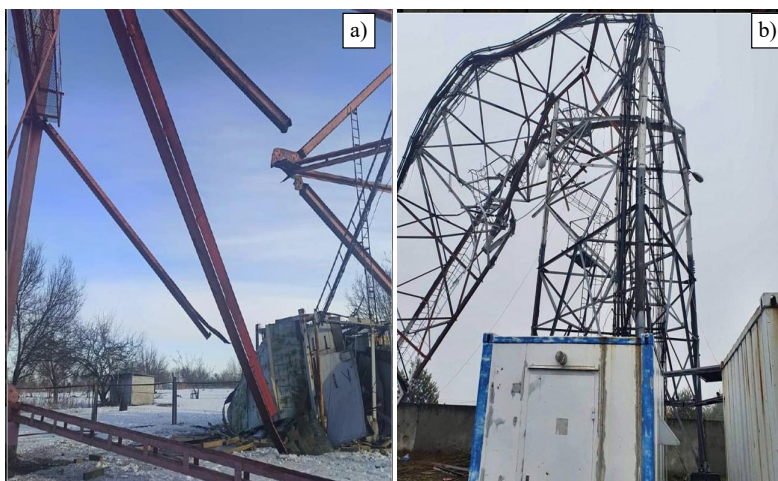
Figure 5.9 shows a photo of the destruction of communication antenna structures as a result of air bombs or cruise missiles hitting the supporting elements in the lower part of the structures. The antenna structures were spatial lattice structures built according to standard designs.

Figure 5.9, a, shows the destruction of a 155-meter-high tower, which is a pyramid with fractures of the belts at the marks +32,000 m and +64,000 m;

further, the tower is a prism with a base of 1.75×1.75 m and a height of 25 m. The tower was hit by high-explosive FAB-500 air bombs, which caused the destruction of the lower section lattice elements of the tower (support braces) and the general collapse of the structure.

Figure 5.9, b shows the destruction of the tower as a result of an air bomb hitting the supporting elements of the tower at an altitude of +5,000...+8,000 m. The destruction of one strut and the adjacent braces also led to the general collapse of the structure.

Figure 5.9 – General collapse of communication antenna structures as a result of air bombs hitting the load-bearing elements of their lower part: a) destruction of elements of the lower section of the tower; b) destruction of one post and adjacent braces
