CHAPTER 7

STEEL SILO STRUCTURES

7.2 Analysis of damage to silo structures caused by off-design impacts

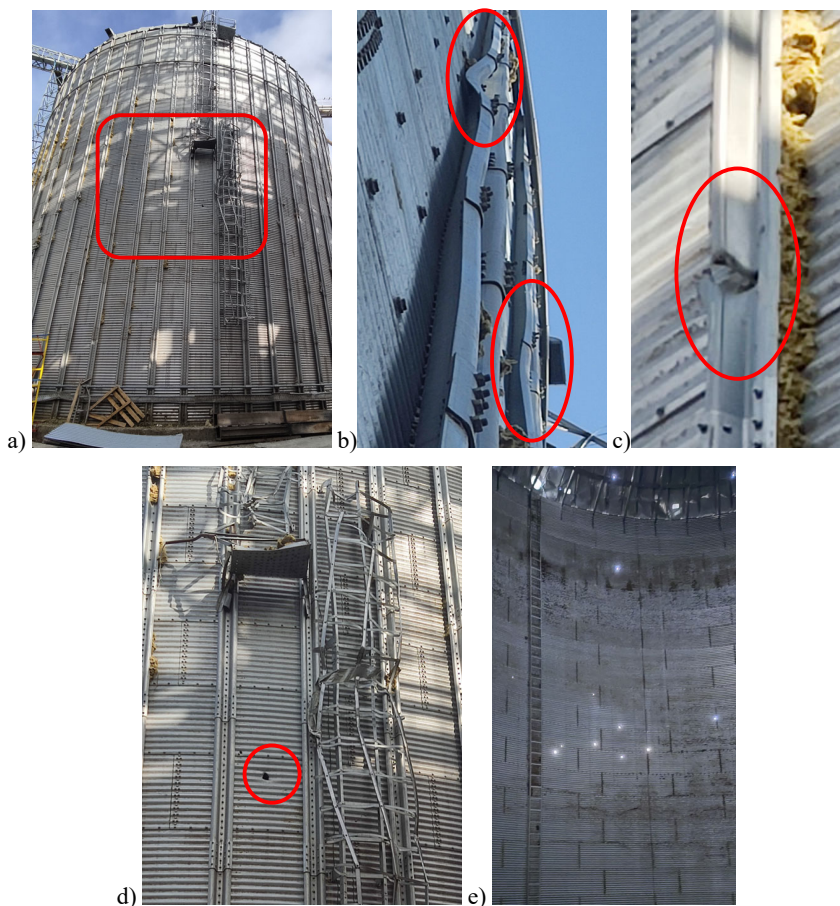
- point damage to the sheets of the silo body belts in the form of various shapes of external dents, notches, through holes and cracks (see Figure 7.4, 7.7);

- loss of the initial design position (curvature, crumpling and bending) of elements of stairs, platforms and fences of silo structures (Figure 7.4 a, c);

**Figure 7.4 (a-e) – Damage to silo No. 7:
vertical stiffeners because of the blast wave
and mechanical action of debris, external ladders
and the wall of the body made of corrugated galvanized steel sheets**

4. Carry out major repairs (replacement) of metal structures and elements of the tank that have lost their shape stability or design position: supporting and enclosing structures of the coating and roof, stairs, auxiliary platforms and fences at the level of the vertical part and roof of the tanks.

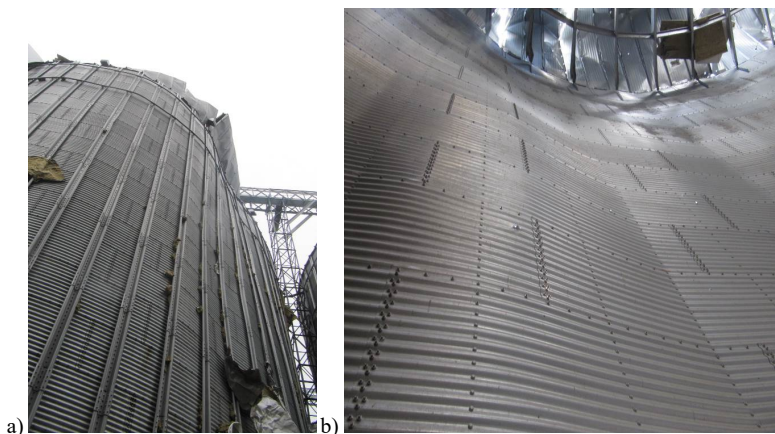
- loss of the design position (appearance of roundness) of the silo body (see Figure 7.5);
- deviation from the vertical straightness of the wall and individual elements of vertical stiffeners along its height by an amount exceeding the maximum permissible value according to the standards;

Figure 7.5 (a-b) – Loss of design position (appearance of roundness) of the wall of the cylindrical part of the silo structure No. 8 by up to 200 mm (external and internal view)

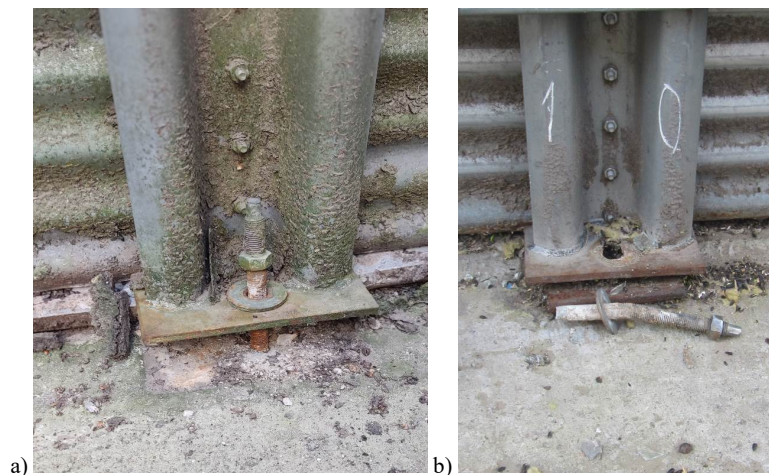
- massive detachment of anchor bolts (studs) along the perimeter of the lower belt of the structure's cylindrical part, which occurred because of deformations and displacements of the silo body (see Figure 7.6);

- the appearance of gaps between the upper plane of the grillage and the lower edge of the 1st belt of the structure sheets by the amount: vertically up to 50 mm; horizontally up to 20 mm (see Figure 7.6);

Figure 7.6 (a-b) – Separation of anchor bolts (studs) along the perimeter of the lower belt of the structure's cylindrical part, which occurred because of deformations and movements of the silo body

1. Stop the operation of the elevator and perform emergency work:
 - 1.1 Urgently unload the silo containers of the grain to prevent the progression of damage and destruction of the silos.
 - 1.2 Strengthen (unfasten) the racks of the technical galleries in places that have been damaged and have changed their geometric position.
2. Carry out complete dismantling of metal structures and elements of tanks No. 7-8, to sort and store them for decision-making on further use.
3. Replace deformed foundation bolts that have been damaged and lost their design functionality. The studs must have a diameter of M20–M24 and a minimum length of clamping in concrete ≥ 400 mm.

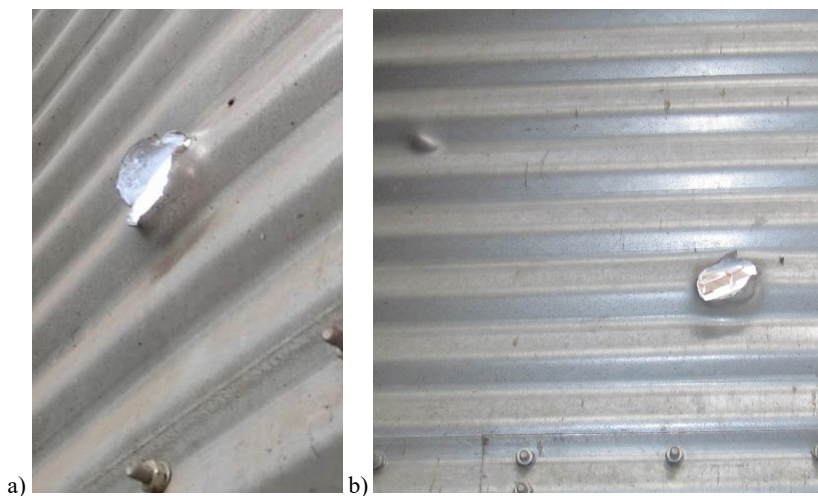
Figure 7.7 (a-b) – Point damage to the corrugated sheets of the silo building body No. 8 in the form of various shapes of external notches and through holes

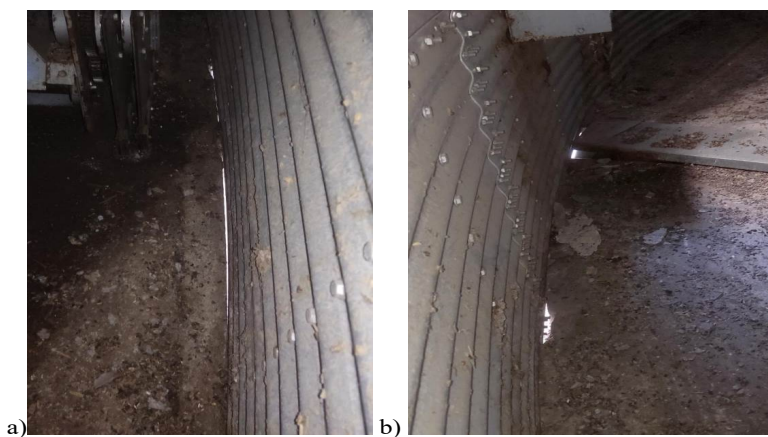
- destruction of the concrete floor along the perimeter of the supporting section of the 1st belt of the structure as a result of its deformation, displacement and movement (see Figure 7.8);

Figure 7.8 (a-b) – Formation of cracks and through holes at floor level due to displacement and movement of silo body No. 11 and local destruction of the concrete floor to a depth of $h=10...50$ mm

5. Carry out repairs of the concrete floor inside the tank after the installation of metal structures and elements.

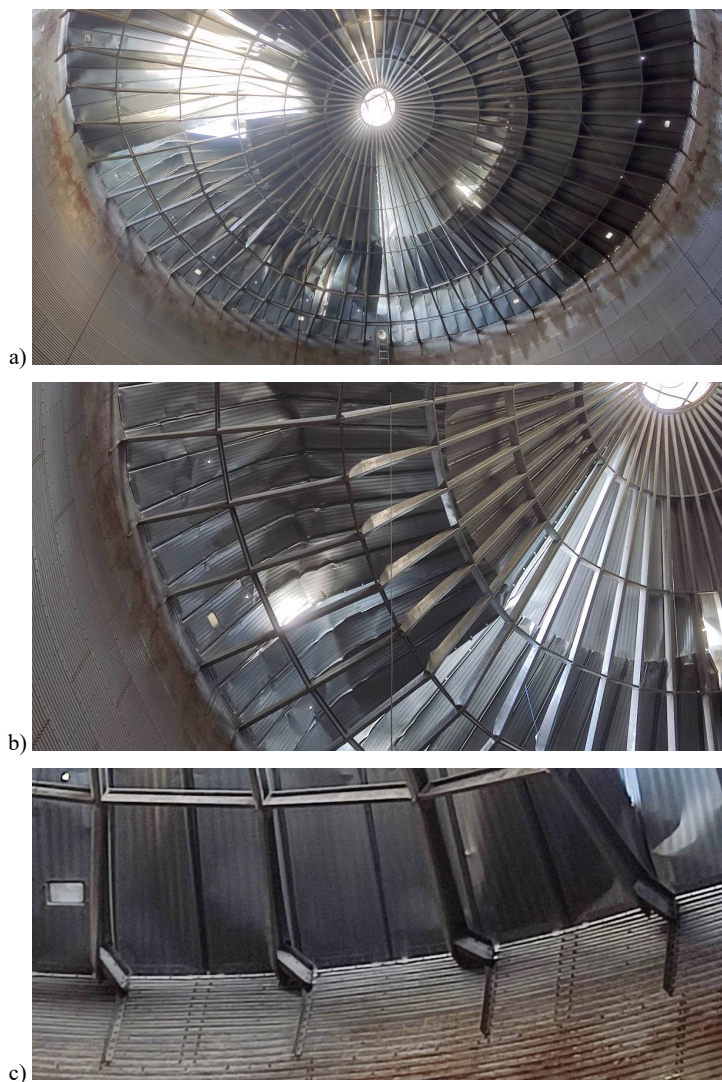
- destruction (deformation) of the spans of the structure's covering due to the crushing of cross-sectional shape and loss of stability of the design position (Figure 7.9);

- formation because of the roof destruction structures and coverings of through openings and cracks with an area of up to 8 m² (excluding the mass destruction of silos No. 7 and 8, (see Figure 7.9a);

Figure 7.9 (a-c) – Destruction of the covering and purlins of the roof supporting system of the silo building No. 9 and the formation of numerous openings and cracks

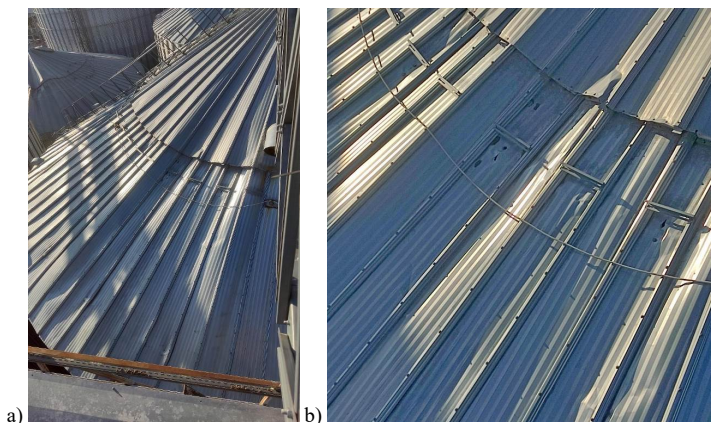
- destruction of the pavement covering up to 65% of the total area;
- separation of the roof cone sheets from the supporting frame elements and convexity and deviation of the shape of the covering decking by up to 1600 mm inside the structure (see Figure 7.10);

Figure 7.10 (a, b) – Loss of the original design form and configuration of the roof and covering of silo No. 2, accompanied by the formation of numerous through-openings in the flooring at the points where individual dowels and self-tapping screws detach

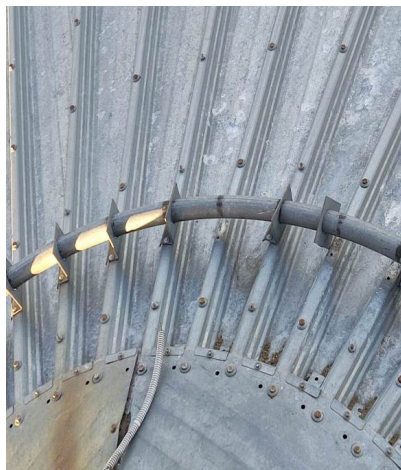
- separation (destruction) of connections from self-tapping screws in the fastening elements of the ring stiffener at the roof level (see Figure 7.11);

Figure 7.11(a-b) – Loss of the initial spatial (shape and configuration) of the roof and silo cover; complete (a) and partial (b) separation of connections from self-tapping dowels in the fastening elements of the ring stiffener at the roof level of building No. 9 (a) and building No. 2 (b)

8. Restore or replace elements of annular and horizontal stiffening elements at the roof level and along the height of the cylindrical part of the tanks.

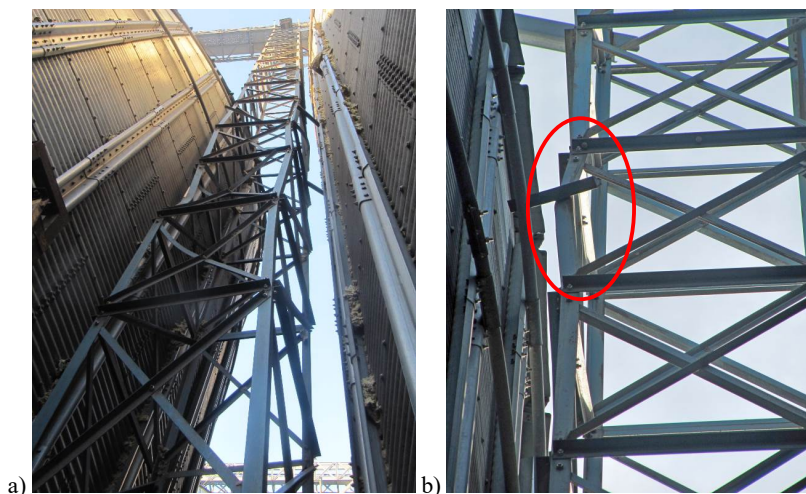
- damage to the elements of the transport gallery racks between the silos (see Figure 7.12).

Figure 7.12 (a, b) – Loss of vertical spatial stability, horizontal sections of the transport gallery racks between silo structures

7. Carry out reinforcement or replacement of the vertical and horizontal elements of the supporting frame of the upper transport galleries. It is necessary to arrange an anti-corrosion coating on these elements.
