CHAPTER 4

BUILDINGS FROM VOLUME BLOCKS

4.2 Analysis of damage to buildings made of volumetric blocks caused by off-design impacts

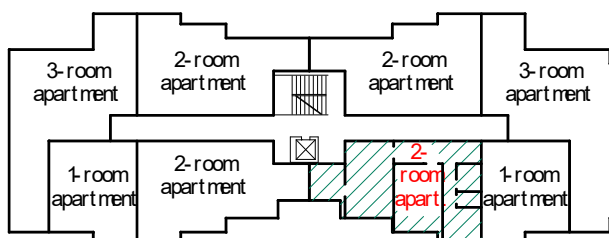
The analysis of damage to buildings made of volumetric blocks caused by off-design impacts was performed using the example of a 9-story residential building, in which a two-room apartment located on the 3rd floor exploded due to gas accumulating in the premises due to a malfunction of a gas cylinder [5; 29]. The location of the 2nd apartment on the building plan is shown in Figure 4.4.

Figure 4.4 – Layout of the 3rd floor of a two-room apartment where an explosion of gas accumulated in the premises occurred
