**CLIMATE ASSESSMENT IN MODERN SUSTAINABLE CATTLE BARNs USING TEMPERATURE-HUMIDITY INDEX**

**Abstract.** The purpose of the study was to study the microclimate in modern uninsulated cattle barns, built with application of the resource-saving technology under the conditions of both natural ventilation and additional normalization of the air environment through the use of powerful axial fans during the heat of summer. The temperature and relative humidity of the cattle barns were investigated directly at the location of the animals in different areas of the premises, recording the indicators continuously for more than a day using remote sensors. Given the high negative correlation between these indices in indoor air ( $r = -0.88$ ,  $P < 0.05$ ), the use of a temperature-humidity index (THI) to characterize the state of the air environment and to evaluate the combined effect of temperature and humidity on the body of the animals was quite reasonable. The mathematical processing of the results was performed using the software STATISTICA 10 (StatSoft, Inc., USA). Differences between indicators determined by the U-test of Mann-Whitney (*U-test*) were considered significant at  $P < 0.0

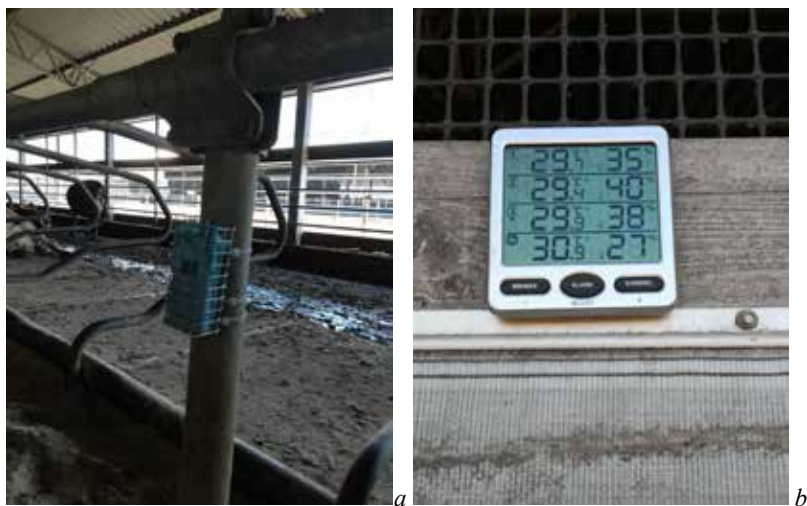
**Figure 1. Measurement of temperature and humidity mode in one of the uninsulated barns: one of the sensors (F007TH) is located in the cow resting stall (a), the Ambient Weather WS-10 thermohygrometer is placed outside the barn (b)**

The researches were conducted under the conditions of industrial dairy complexes of the Limited Liability Company MVK Yekaterynoslavskiy and the Private Joint-Stock Company Argo-Soiuz in Dnipropetrovsk region. Indoor and outdoor temperature and humidity were evaluated using an Ambient Weather WS-10 thermohygrometer (Ambient LLC, USA) for more than 30 hours continuously, with sensor readings every 5-20 minutes. The remote sensors (F007TH) were placed at the resting level of the animals (at a height of 50 cm from the floor) directly between the first and second boxes on the side of the end sections (from the south-east and northwest) and in the central part (between the 1st and the 2nd boxes), just away from the interstall pass with the group drinking pan. Protective covers for the sensors in the form of a solid metal mesh were fixed in the stalls in advance so that the animals could get used to them. The WS-10 thermohygrometer panel was placed outside the premise in shade (Figure 1). Before operation, the sensors and thermohygrometer were adjusted using an Assman aspiration psychrometer [5] in accordance with GOST 6353-52. As well as in our researches, scientists [2, p. 203] measured the temperature and humidity of the air in real time using electronic sensors that were directly above the animal's stalls at a height of 2.5 m. The location of the recorders above the floor at such a distance was motivated by their inaccessibility by animals and maintenance staff (they should not have impede the execution of technological processes on operations). Although the location of the sensors was convenient for data collection, it did not fully reflect the state of the environment at the location of the animals, which directly affects them. We understand that in our case, the presence of animals near the sensors could have influenced their measurements by direct contact (licking, etc.), but the advance (few days before) fastening of covers from the metal mesh without the sensors in the boxes had to prevent “excessive interest” of the cows in the placed equipment.

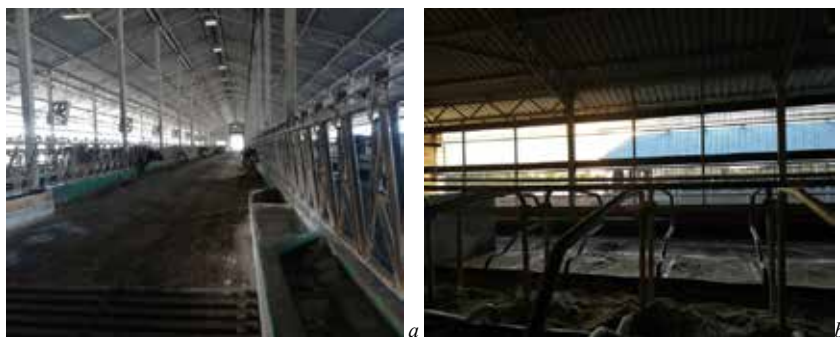
**Figure 2. Lightweight premise frame for 600 milk cows: a) inside view of the premise from the side of feed table; b) boxes for cows rest**

The LLC MVK Yekaterynoslavskyyi ( $48^{\circ}34'03.1''N$ ,  $34^{\circ}54'47.0''E$ ) is a high-tech innovative dairy complex for keeping Swiss breed. The cows are kept in modern housing for 600 units of milking herd (Figure 2). The premises are placed longitudinally in a direction from northeast to southwest relative to the sides of the world. Each of them has two rows of stalls ( $1.2 \times 2.5$  m) in four sections (150 units each). Special rubber mattresses create comfort for resting in stalls. The dimensions of the premises in the axes are  $240.0 \times 32.4$  m. The side walls, 3.0 m high, have a reinforced concrete base (0.4 m high) with tarpaulin curtains. Additional day and night

(infrared) illumination provides the necessary light mode indoors. The roof is double-pitch, made of sandwich panels, which allows to maintain the relative constancy of the temperature in the cattle barn, preventing it from overheating or cooling. The ridge height of the premise is 9 m. In the hot season, fans with a large diameter are included to enhance the air exchange. The DeLaval milking parlor collector with Dairy Comp-350 herd monitoring system (2×20parallel type) also has an irrigation system. A mixed diet, balanced according to the nutrition requirements of Nutrient Requirements of Dairy Cattle (2001), is distributed to the feed tables. Balancing of feeding and selection of components of feed mix depending on live weight and performance of cows is carried out in cooperation with the representatives of Cargill (Cargill AT, LLC). Each technological section is equipped with separate feeders with salt, chalk and soda, which allows the animals to eat them freely when needed. In interstall passes there are placed group automated drinking pans with water heating in winter. Manure from the passes is removed by a mobile vehicle (Bobcat S250) when the animals are in the milking parlor.

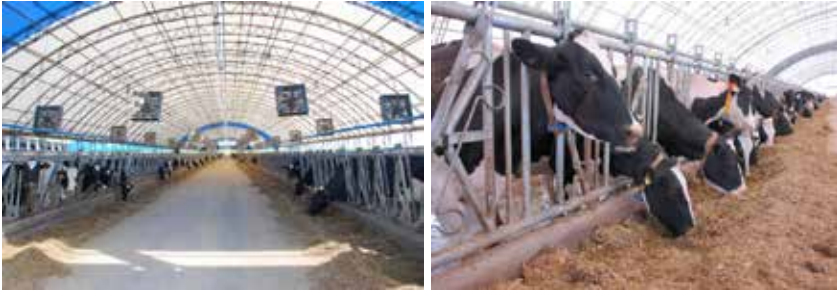
**Figure 3. Non-insulated barn of hangar type with tent coating**

The dairy complex of Private Joint-Stock Company Agro-Soiuz ( $48^{\circ}28'44''\text{N}$ ,  $35^{\circ}36'46''\text{E}$ ) has breeding status for breeding Holstein breed. Cows are kept free in lightweight buildings built with resource-saving technology. A microclimate study was conducted in a hangar type premise with medium-lactation animals (91 to 210 days). Their number in the sections, designed for 150 cows, was 127-143 units. The average daily milk yield for this technology group was 24-26 kg. This barn is located from north to south relative to the sides of the world, has tent covering, fitted with plastic side curtains, its dimensions in the axes are  $124 \times 34.5$  m, ridge height – 8.25 m. The total area of the premise per cow is  $4.3 \text{ m}^2$  (including the stall –  $2.24 \text{ m}^2$ ). It is equipped with a feed table and group automated drinking pans (Figure 3).

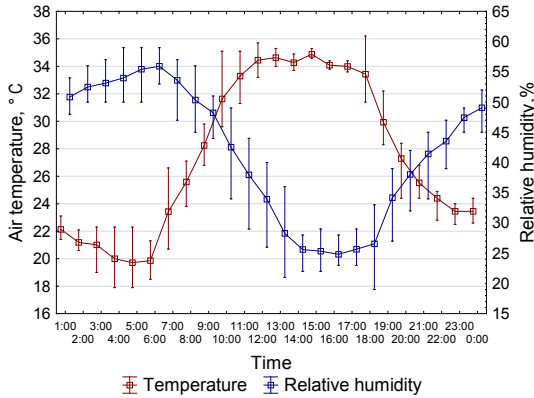
**Figure 6. Temperature and humidity regime inside the uninsulated barn (temperature – dark-red line; relative humidity – blue line), n = 402**

The obtained data indicate that the temperature-humidity regime in the uninsulated barn was changing significantly during the day (Figure 6). The correlation coefficient between the temperature and the relative humidity of the premise was high  $r = -0,884$  ( $P < 0,05$ ).

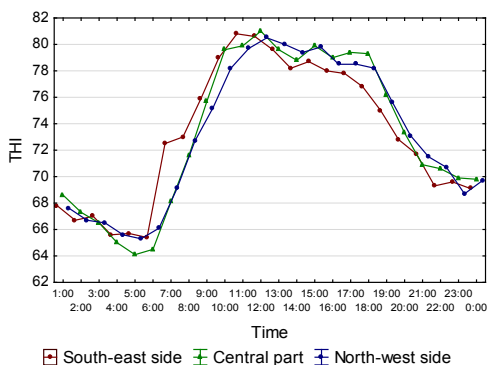
**Figure 8. Dynamics of temperature-humidity index in the uninsulated barn (southeast side – dark-red line; central part – green line; northwest side – blue line), n = 134**

However, in different parts of the premise (Figure 7), depending on the time of day, the largest difference in the value of THI was 2.5-4.4 units, exceeding the comfortable value for dairy cows (THI <68), even in the morning and evening hours.

We associate the observed differences in the temperature-humidity index in different parts of the premise with its design features and the location relative to the sides of the world, i.e. with different level of their heating by rays of sunlight, which should include a selective approach to the application of additional cooling (for example, irrigation ) based on the differences found.
